Detailed Bridge Inspection Report

Indiana & Ohio Rail Corporation

DT&I Line (Old South Charleston Portion Only)

Springfield, OH to Jeffersonville, OH

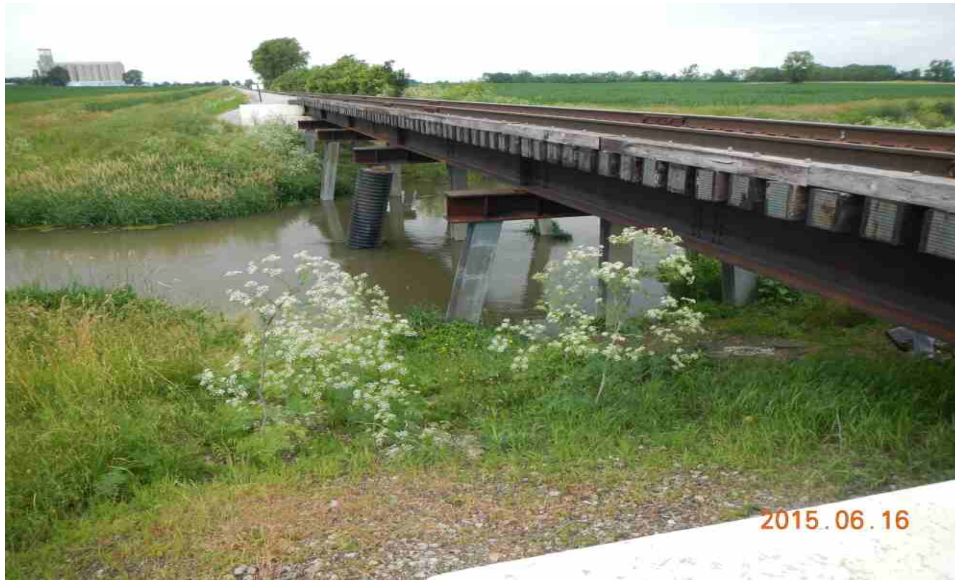
Bridge 222.22

Abutment 1	Slight undermining Minor ballast on seat
Abutment 2	Ballast on Seat
Steel Bent 2 Bearings	Bearing 3 - 2 Connection Bolt Nuts - Missing Bearing 6 - 2 Connection Bolt Nuts - Missing Bearing 7 - 2 Connection Bolt Nuts - Missing
Approaches	Low
Ties	OK
Line and Surface	OK

Item#	Priority	Repair Description
1	4	Refer to the Boring/Structure Report for Priority 4 Conditions.

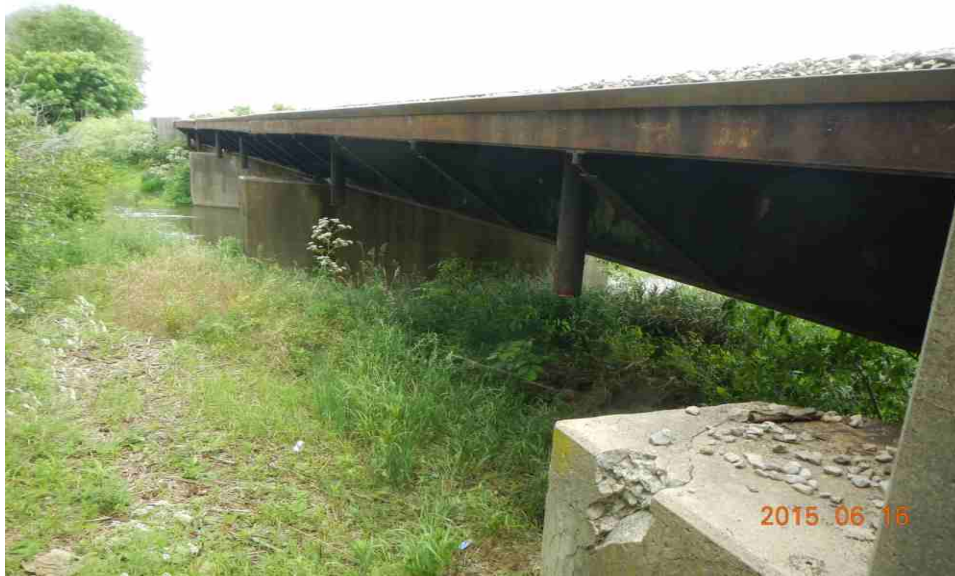
Bridge 223.52

Findings:	Finding Notes:
Abutment 1 Bearings	Minor spalling East side Minor cracking of concrete Surface rust on Steel
Abutment 2 Bearings	Minor cracking on concrete Surface rust on Steel Bearing 4 Outboard Anchor Bolt - Bent
Concrete Pier 1 Bearings	Minor rust and corrosion on Masonry Plates
Concrete Pier 2 Bearings	Minor rust and corrosion on Masonry Plates and Anchor Bolts
Span 1	West Side Top Steel Retainer - Missing Light corrosion developing Surface rust on all Steel
Span 2	West Side Top Steel Retainer Angle missing Light corrosion developing Surface rust on all Steel
Span 3	Light corrosion developing Surface rust on all Steel
Approaches	OK
Decking	Losing Ballast through Drainage System
Line and Surface	OK
Other	Loose Anchor Bolt Nuts throughout

Item#	Priority	Repair Description
1	4	Refer to the Boring/Structure Report for Priority 4 Conditions.
