Detailed Bridge Inspection Report

Indiana & Ohio Rail Corporation

DT&I Line (Old South Charleston Portion Only)

Springfield, OH to Jeffersonville, OH

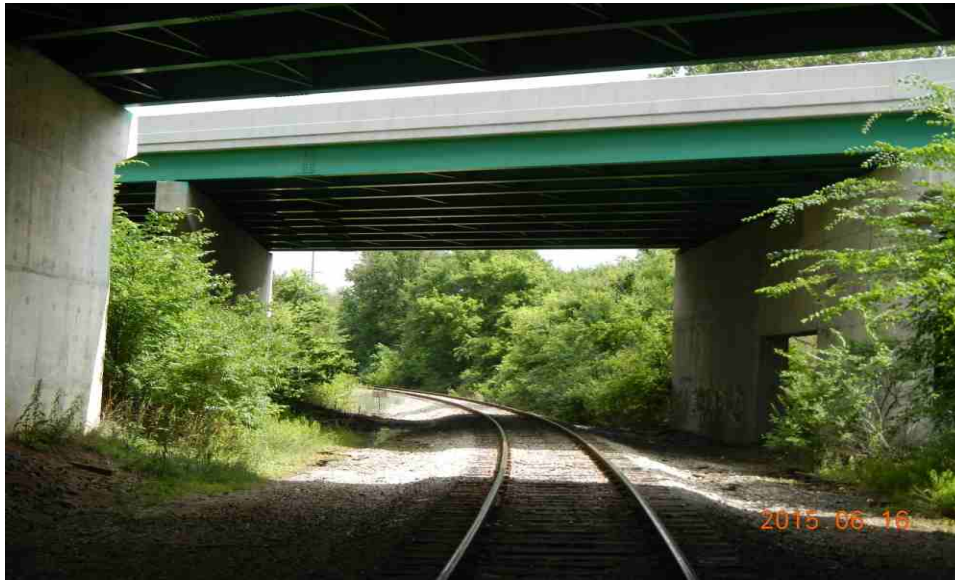
Bridge 201.25 OHH

No readily visible defects were identified from the track

Item#	Priority	Repair Description
1	5	No repair recommendations required at the time of inspection

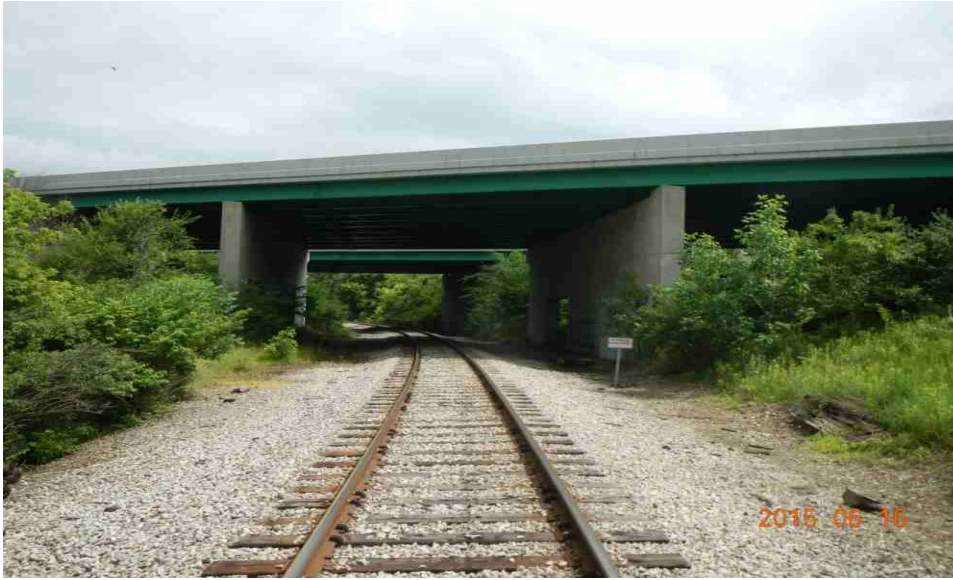
Bridge 201.27 OHH

No readily visible defects were identified from the track

Item#	Priority	Repair Description
1	5	No repair recommendations required at the time of inspection

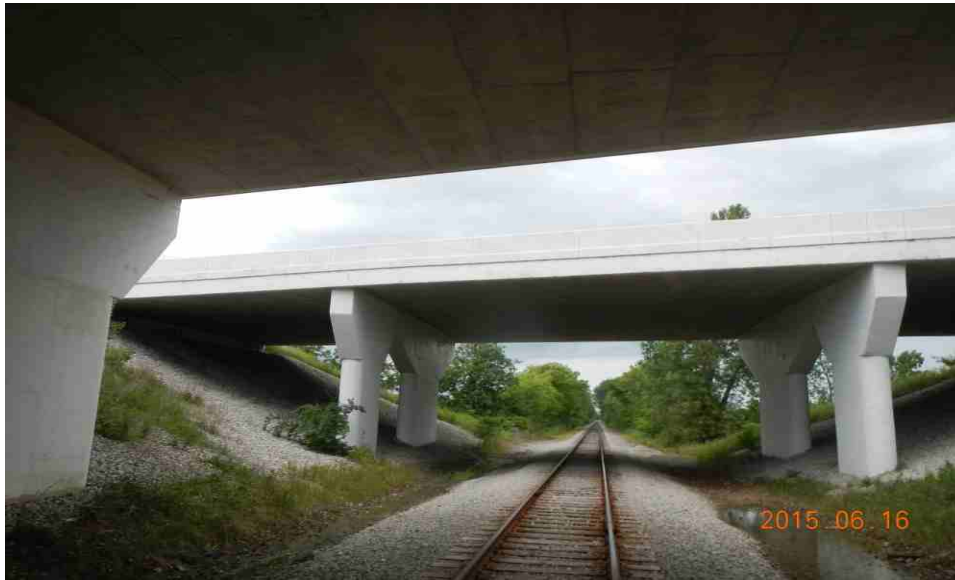
Bridge 223.20 OHH

No readily visible defects were identified from the track

Item#	Priority	Repair Description
1	5	No repair recommendations required at the time of inspection

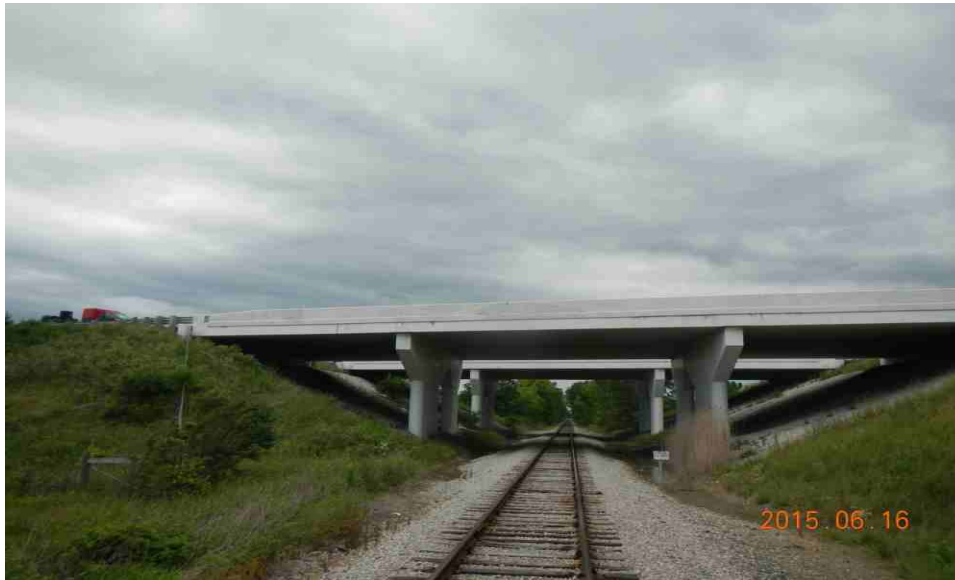
Bridge 223.22 OHH

No readily visible defects were identified from the track

Item#	Priority	Repair Description
1	5	No repair recommendations required at the time of inspection
